REC-ERC-88-6

1986 LAKE POWELL SURVEY

December 1988

U. S. Department of the Interior
Bureau of Reclamation

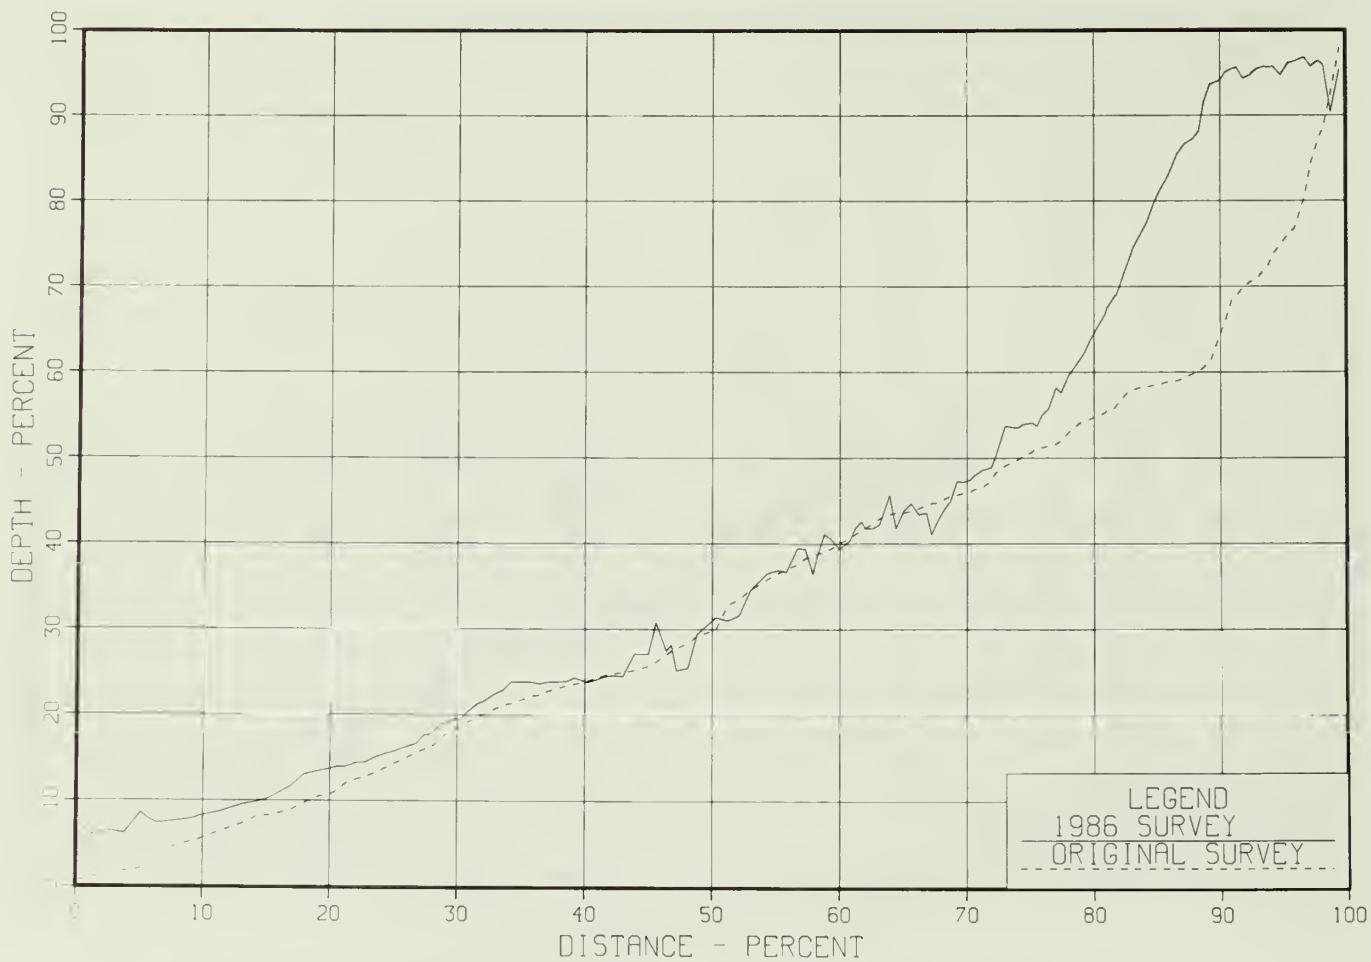
Figure 16. – Percent depth versus percent distance for Lake Powell above Glen Canyon Dam.

The longitudinal profiles for the Colorado River channel are shown in dimensionless form on figure 16, a plot of percent depth versus percent distance. This plot permits the comparison of the deposition profile versus original river surface profile without scale interference. The percent depth of the original survey

is the ratio of the river water surface depth at each range-line location to the total depth. In comparison, the percent depth of the 1986 survey is the ratio of the average bottom depth at each range-line location to the total depth. The total depth of 564 feet represents the difference between the top of the spillway gates, elevation 3700, and the original low point in the reservoir profile, elevation 3136. The percent distance was computed as the ratio of the channel distance between the dam and a given range line to the total distance of 185.7 miles from the dam to the upstream point in the river where the 3,700-foot contour crosses.

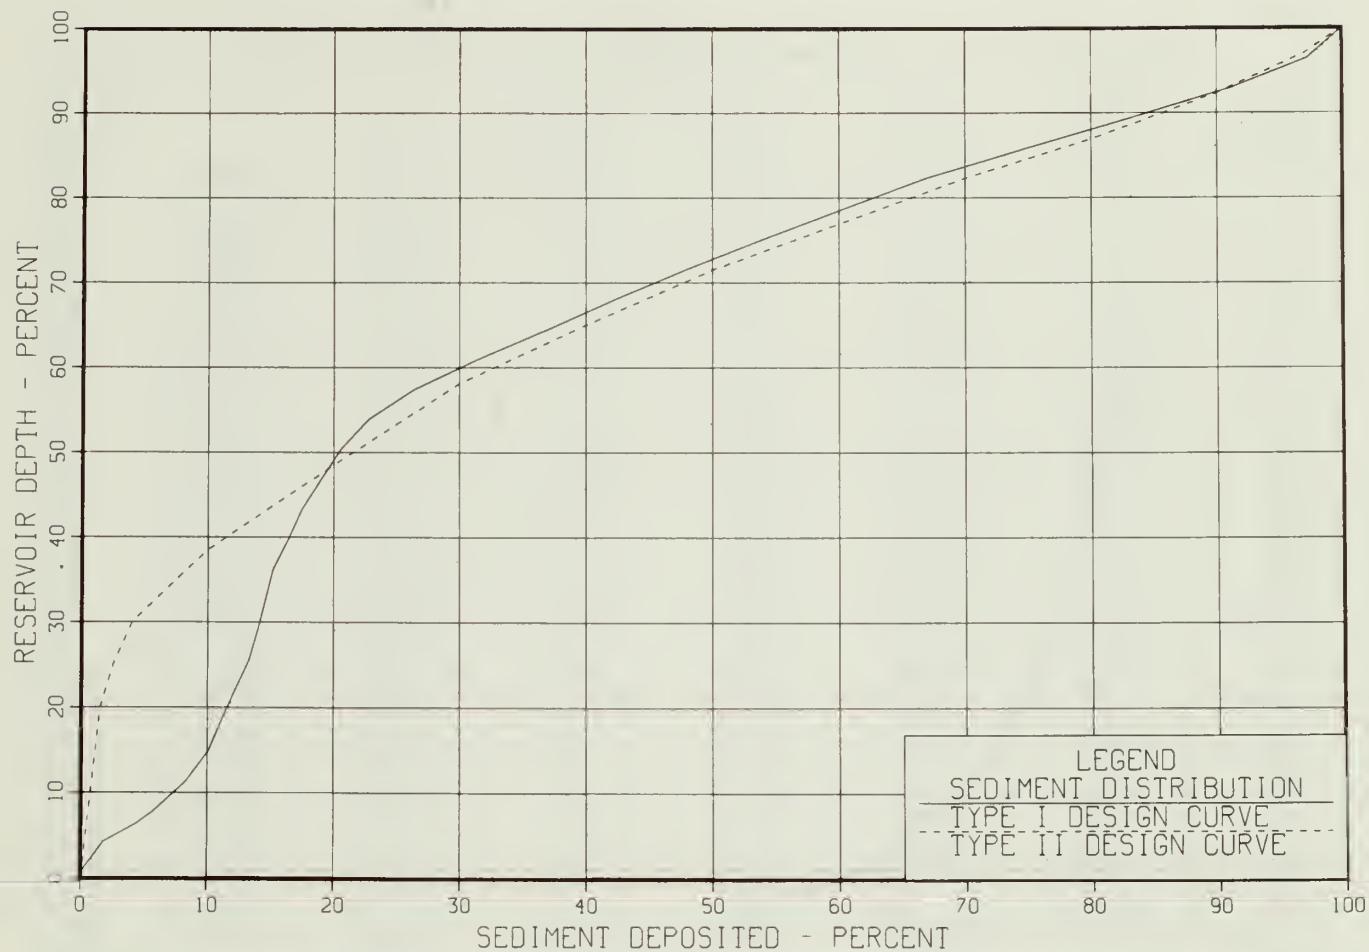
Figure 19. – Measured sediment distribution shown as percent depth versus percent deposited.

The measured distribution of sediment in the reservoir is plotted on figure 19 as the percent reservoir depth versus percent sediment deposited. The sediment volumes and depth data are from columns (8) and (9) of table 4. Design curves for Type I and Type II reservoirs are also plotted against this measured curve. The curve indicates that, during the first period

of reservoir operation, the measured sediment distribution is best described by a Type I design curve, although a Type II curve was used during the planning studies. The Type I curve describes a reservoir with sediment always or nearly always submerged, while the Type II curve describes a reservoir with sediment exposed by normally moderate to considerable reservoir drawdown.

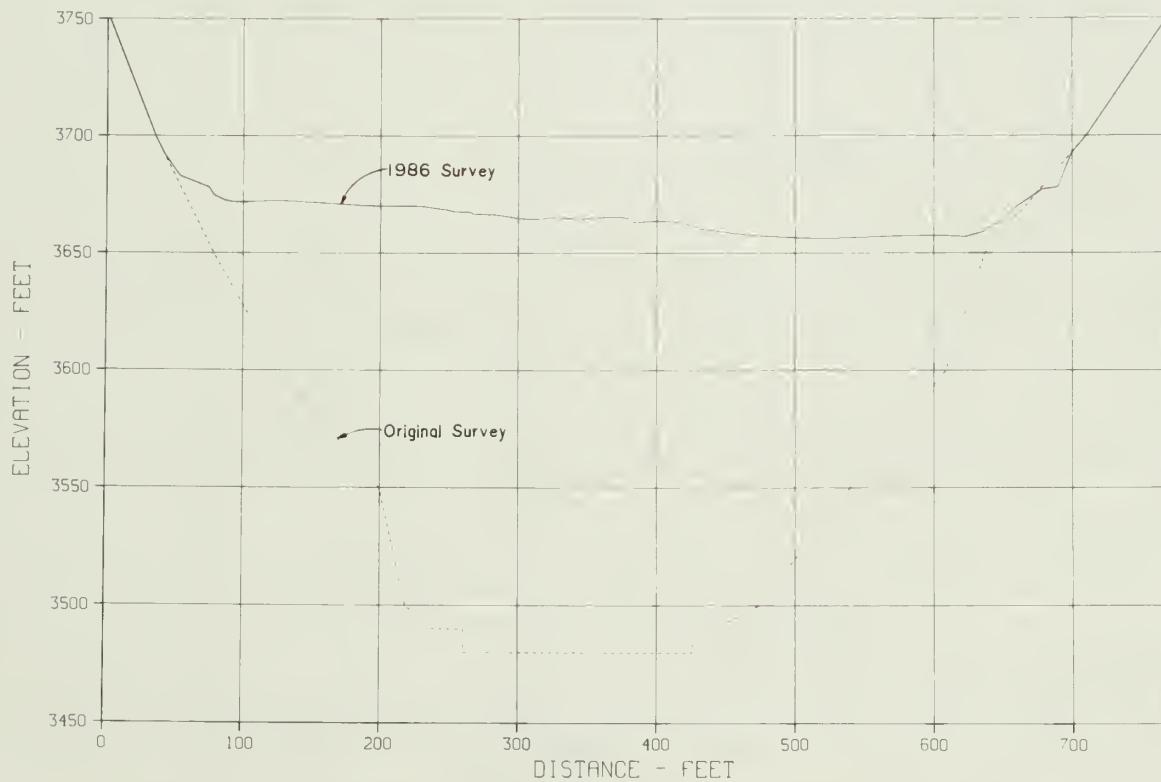
Figure 28. – Original and 1986 sedimentation range profiles, range 324, Colorado River.

at range-line 324 in the Cataract Canyon area. These average sediment depth calculations, shown in last column of table 6, were determined by taking the average bottom elevation and subtracting the original river surface elevation determined from the topographic maps. Since the pre-dam cross sections begin at the old river surface and not at the channel bottom, a few range lines in areas having little or no sediment show negative numbers.
